Unbreakable Prodigy ?

Core capability for Chemistry Research – EPSRC & The University of Edinburgh

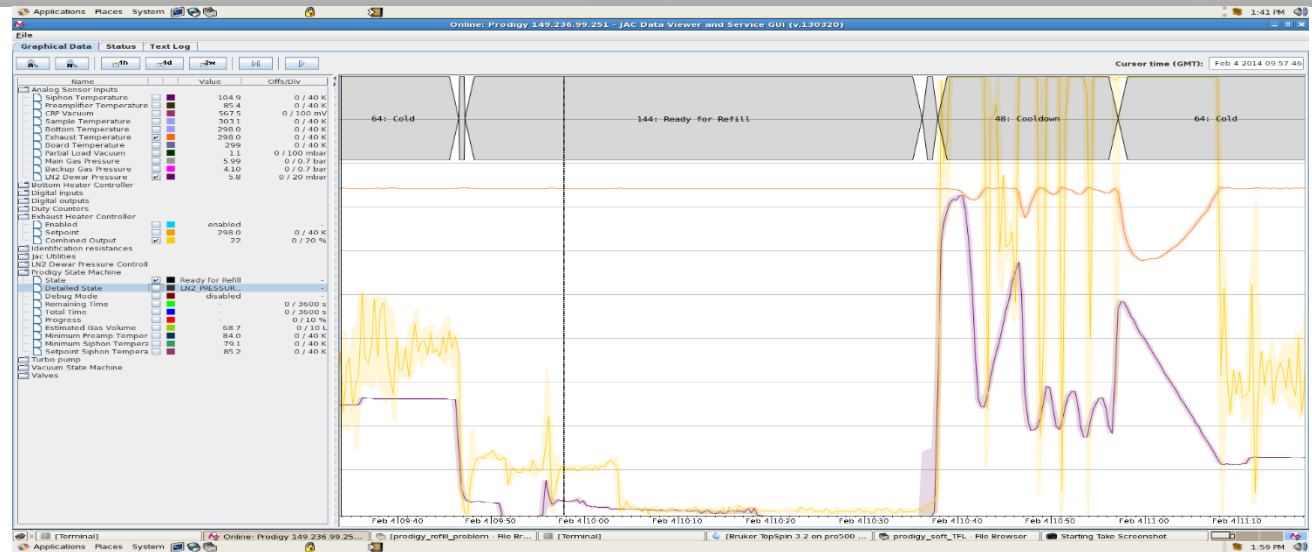
Dewar pressure:
DP 6-8 mbar
(purple)
Exhaust temp:
298 K
(orange)

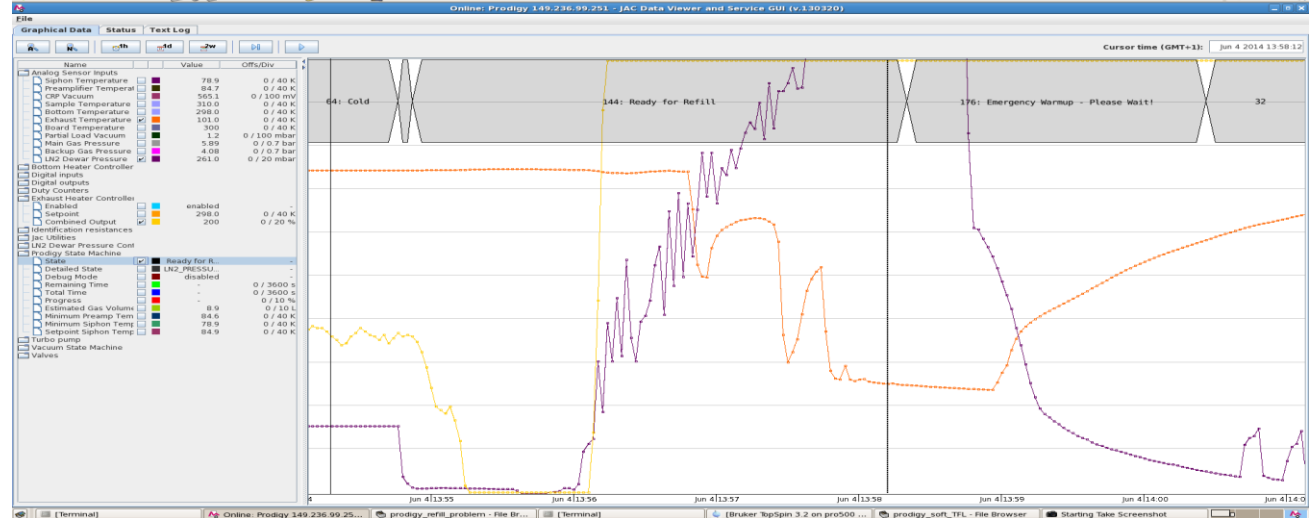
Dewar pressure:
DP 260 mbar !
Heater – 200 % !
Exhaust temp:
Below 100 K !

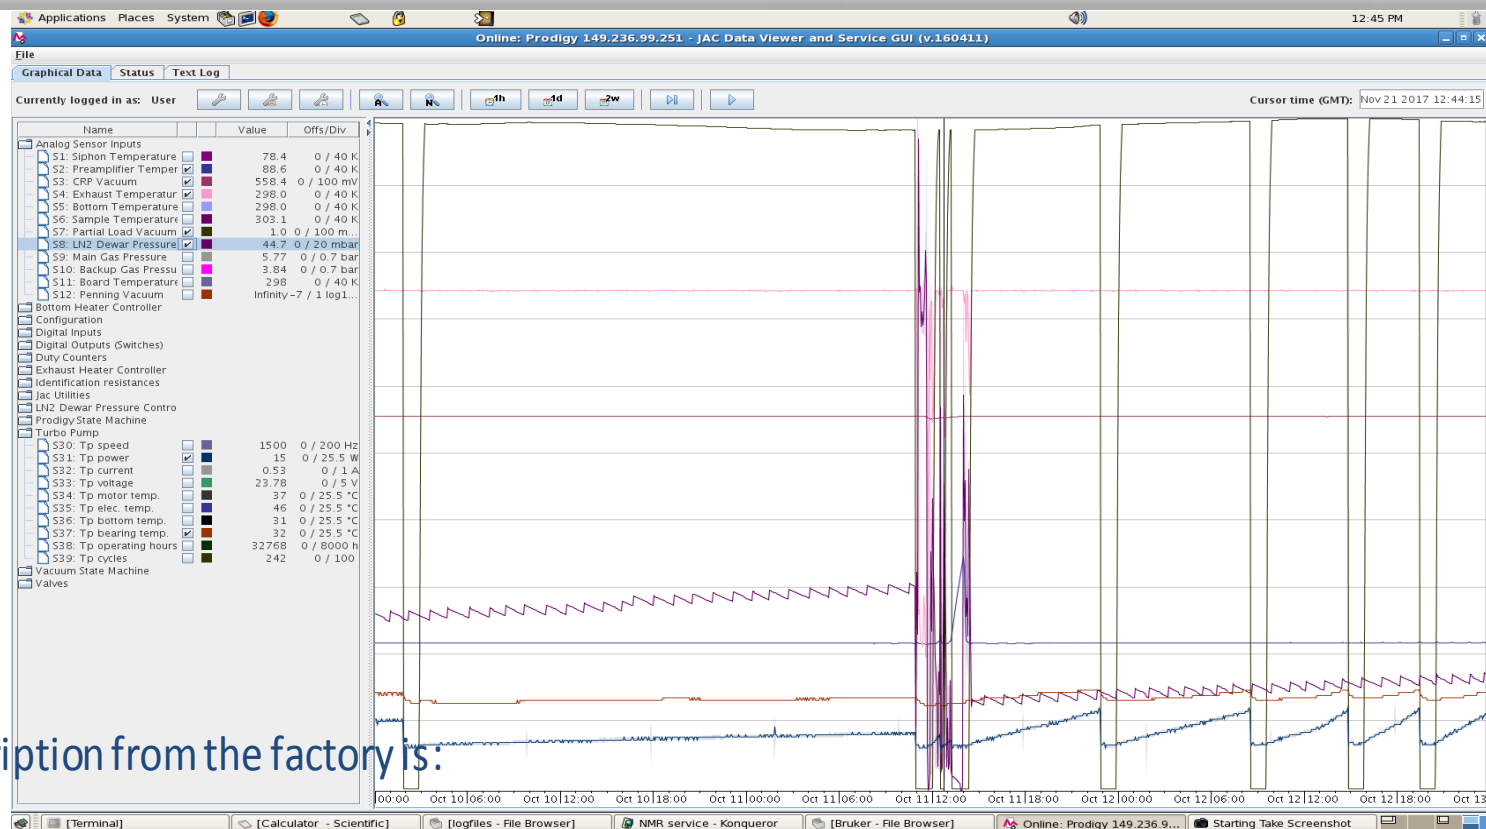
Roughing
pump -
Green
Turbo
pump -
Blue
DP -
purple

The failure description from the factory is:

The C1 plug and the vacuum valve was leaking -> replaced; the vacuum sensor had a shortcut and was defective -> replaced; the preamp sensor showed a false value, so it had to be replaced; probe full NMR test passed; cleaned and tested

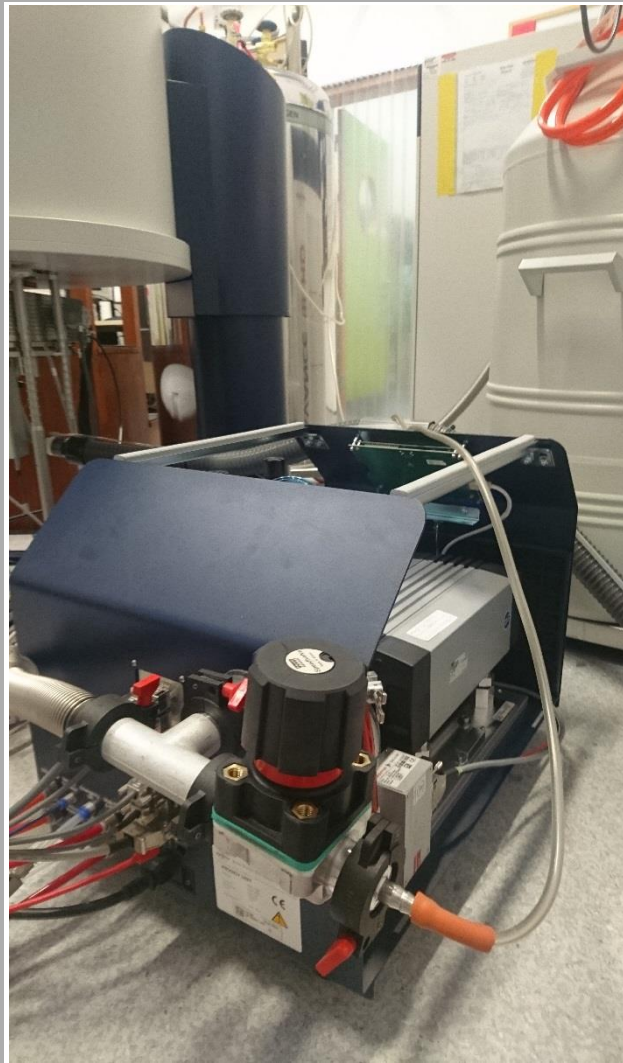
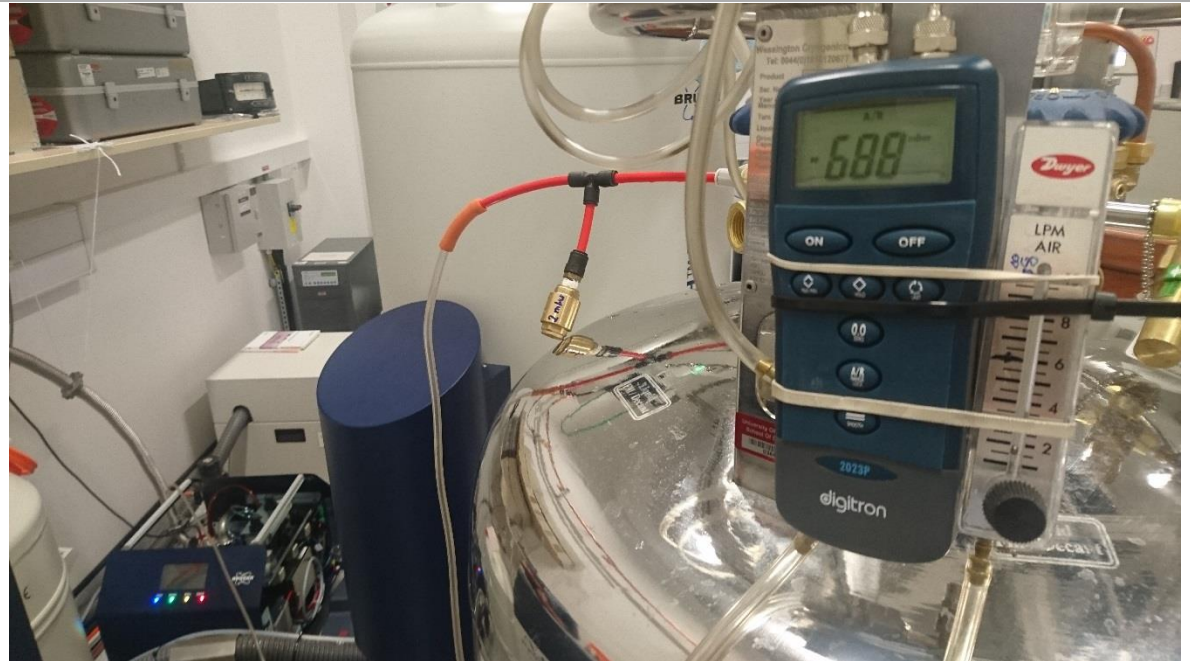
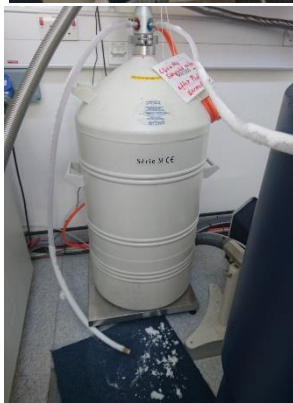
Attempts to revitalise vacuum by purging:

Purging the probe by dry nitrogen gas helped for about a week but then failed again and again.
